A Littoral and sublittoral benthic survey of the construction footprint for the Carrick landing craft/bund facility, Loch Goil

Prepared for UPM Tilhill, 4th March 2015

Client:	UPM Tilhill					
Project Title:	Landing craft project - Carrick					
Document Title:	A Littoral and sublittoral benthic survey of the construction footprint for the Carrick landing craft/bund facility, Loch Goil					
Document No:	GSME150304					
This Document Comprises:	DCS	TOC	Text	No. of Appendices	List of Figures	List of Tables
	1	1	8	4	0	0

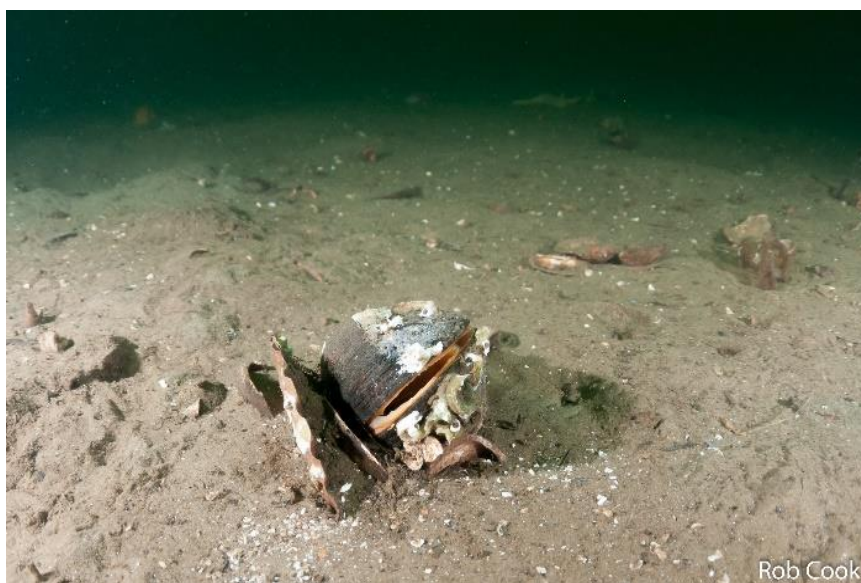
Image 1. Habitat SS.SMx.IMx. Example image from transect 1 showing a live *Modiolus modiolus*.

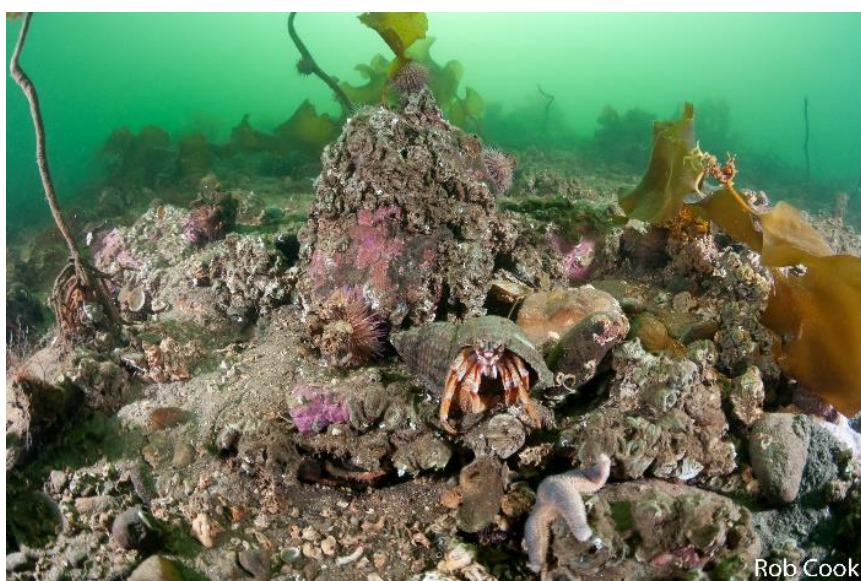
Image 2. Habitat IR.LIR.KVS. Example image from transect 1.

The second habitat encountered was a relatively steep muddy cobble and boulder slope, with sometimes dense sugar kelp *Saccharina latissima*. The slope rises some 4m from the deeper habitat,

and was classified as IR.LIR.KVS (Kelp in variable or reduced salinity) (Connor et al., 2004). This habitat was absent on transect 5, but ranged from 75m to 45m from the shore on the other transects, this related to approximately 5m to 0m below chart datum.

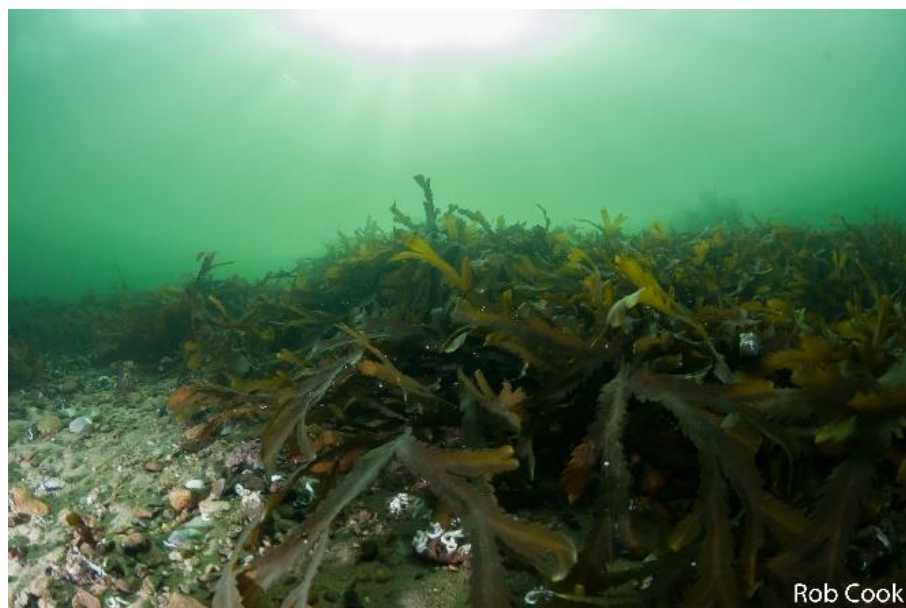
Image 3. Habitat LL.LLR.FVS. Example image from transect 1.

The third habitat started between 45 and 40m from the shore, the deeper end approximately corresponding to chart datum and therefore exhibiting a typical intertidal seaweed succession pattern. This habitat was broadly classified as LL.LLR.FVS (Fucoïds in variable salinity) (Connor et al., 2004).

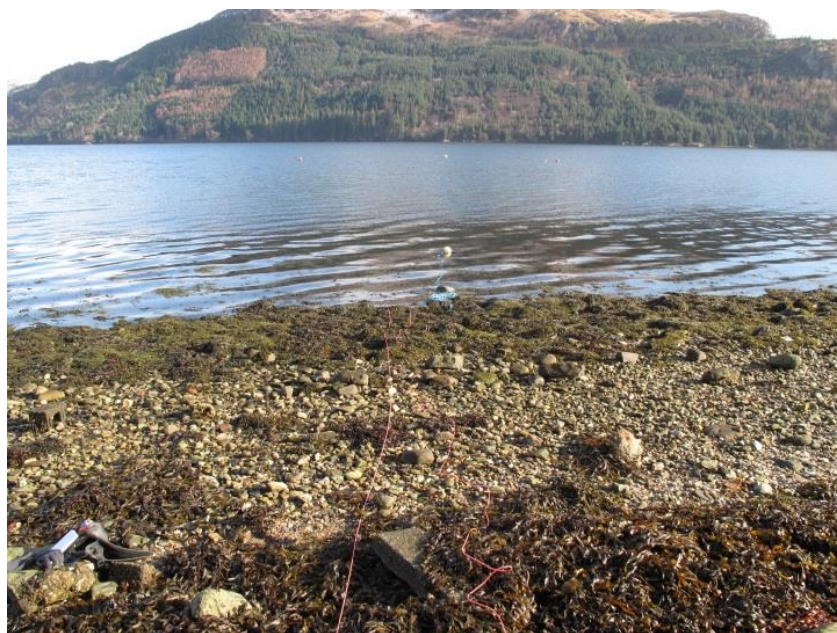
Image 4. Top of transect 1, looking offshore on a bearing of 60°. The three recorded littoral zones are visible down the shore.

The visual littoral surveys undertaken at the mooring pin locations (locations determined from the supplied plans) recorded 3 zones approximately 4m wide running down the shore. The upper zone consisted of large stones and mixed sediments, topped with a strandline composed of mixed drift furoid seaweed. The midshore zone comprised cobbles on mixed sediment, with scattered *Fucus vesiculosus* (15%), *Pelvetia canaliculata* occasional (5%) and *Semibalanus balanoides* (5%). The lower mid shore was very similar to the mid shore but with 80% cover of furoids. The lower shore was not accessible by foot during the survey period, but diver observation confirmed the presence of *Fucus vesiculosus* and *Ascophyllum nodosum*. This littoral community pattern, typical for Scottish sea lochs, was broadly consistent across the full survey area.

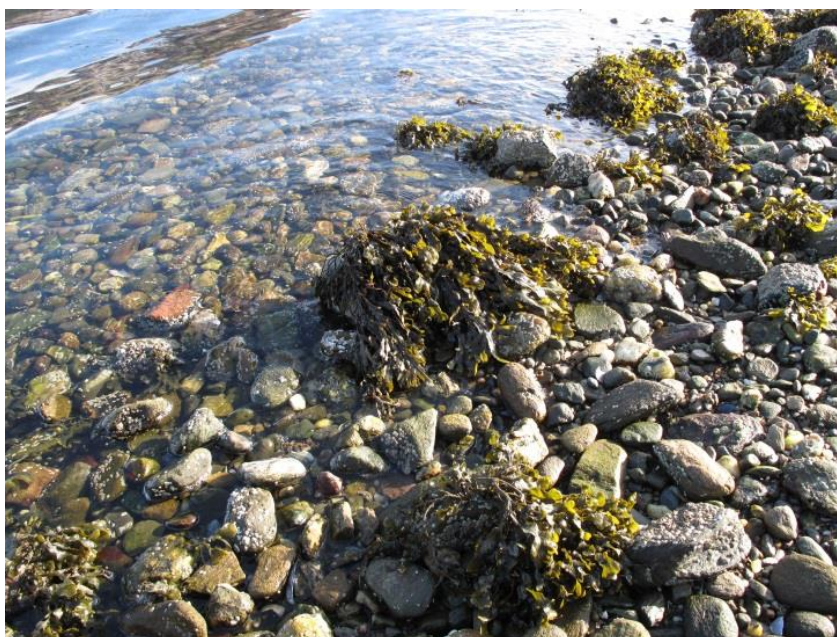
Image 5. Midshore zone, showing patchy *Fucus vesiculosus* cover and occasional barnacles *Semibalanus balanoides*.
